"LANDSLIDE INVESTIGATIONS, MAIN NORTH LINE RAILWAY,
SOUTH ISLAND, NEW ZEALAND"

A thesis
submitted in partial fulfilment
of the requirements for the degree
of
Master of Science in Engineering Geology
in the
University of Canterbury

G. Guy Grocott, BSc, BSc (Hons.)

May, 1977

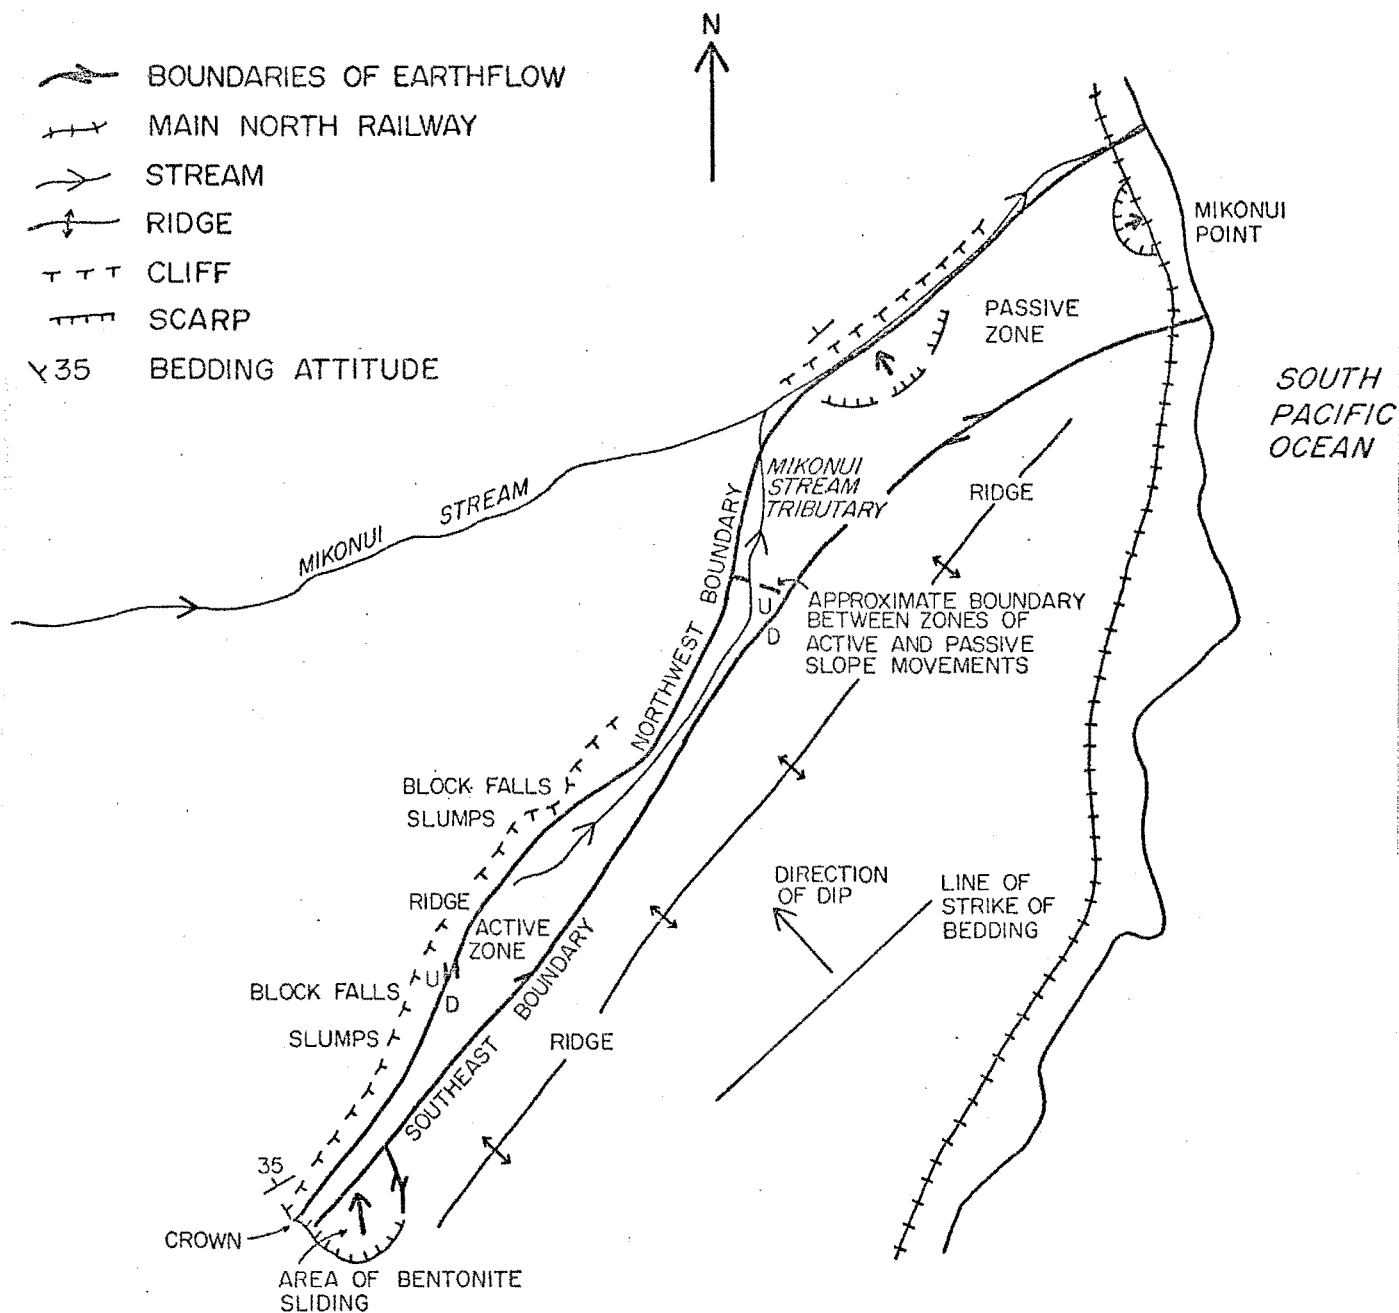
At several localities on the earthflow, or its environs, secondary landsliding occurs. The most significant locality is in the ridge adjacent to the southeast margin of the earthflow, at a height in the ridge equal with the crown (Fig. 26). Here, translational sliding of a large soil block towards the head of the earthflow occurs. This area is discussed in more detail in section 4.43. A further area of secondary slope activity occurs on the northwest edge of the earthflow between two points adjacent

Slope failure at this locality within bentonitic soils is attributed firstly to the low shear strength of the sediment, due to the presence of the clay mineral montmorillonite, and secondly to the unfavourable attitude of bedding, a dip towards the centre of the earthflow (section 4.41). Displacement of the soils towards the head of the earthflow takes place by translational sliding along and down bedding planes.

FIG. 26: GEOLOGICAL STRUCTURE IN RELATION TO TREND OF EARTHFLOW AND LOCATION OF AREAS OF SECONDARY LANDSLIDING.

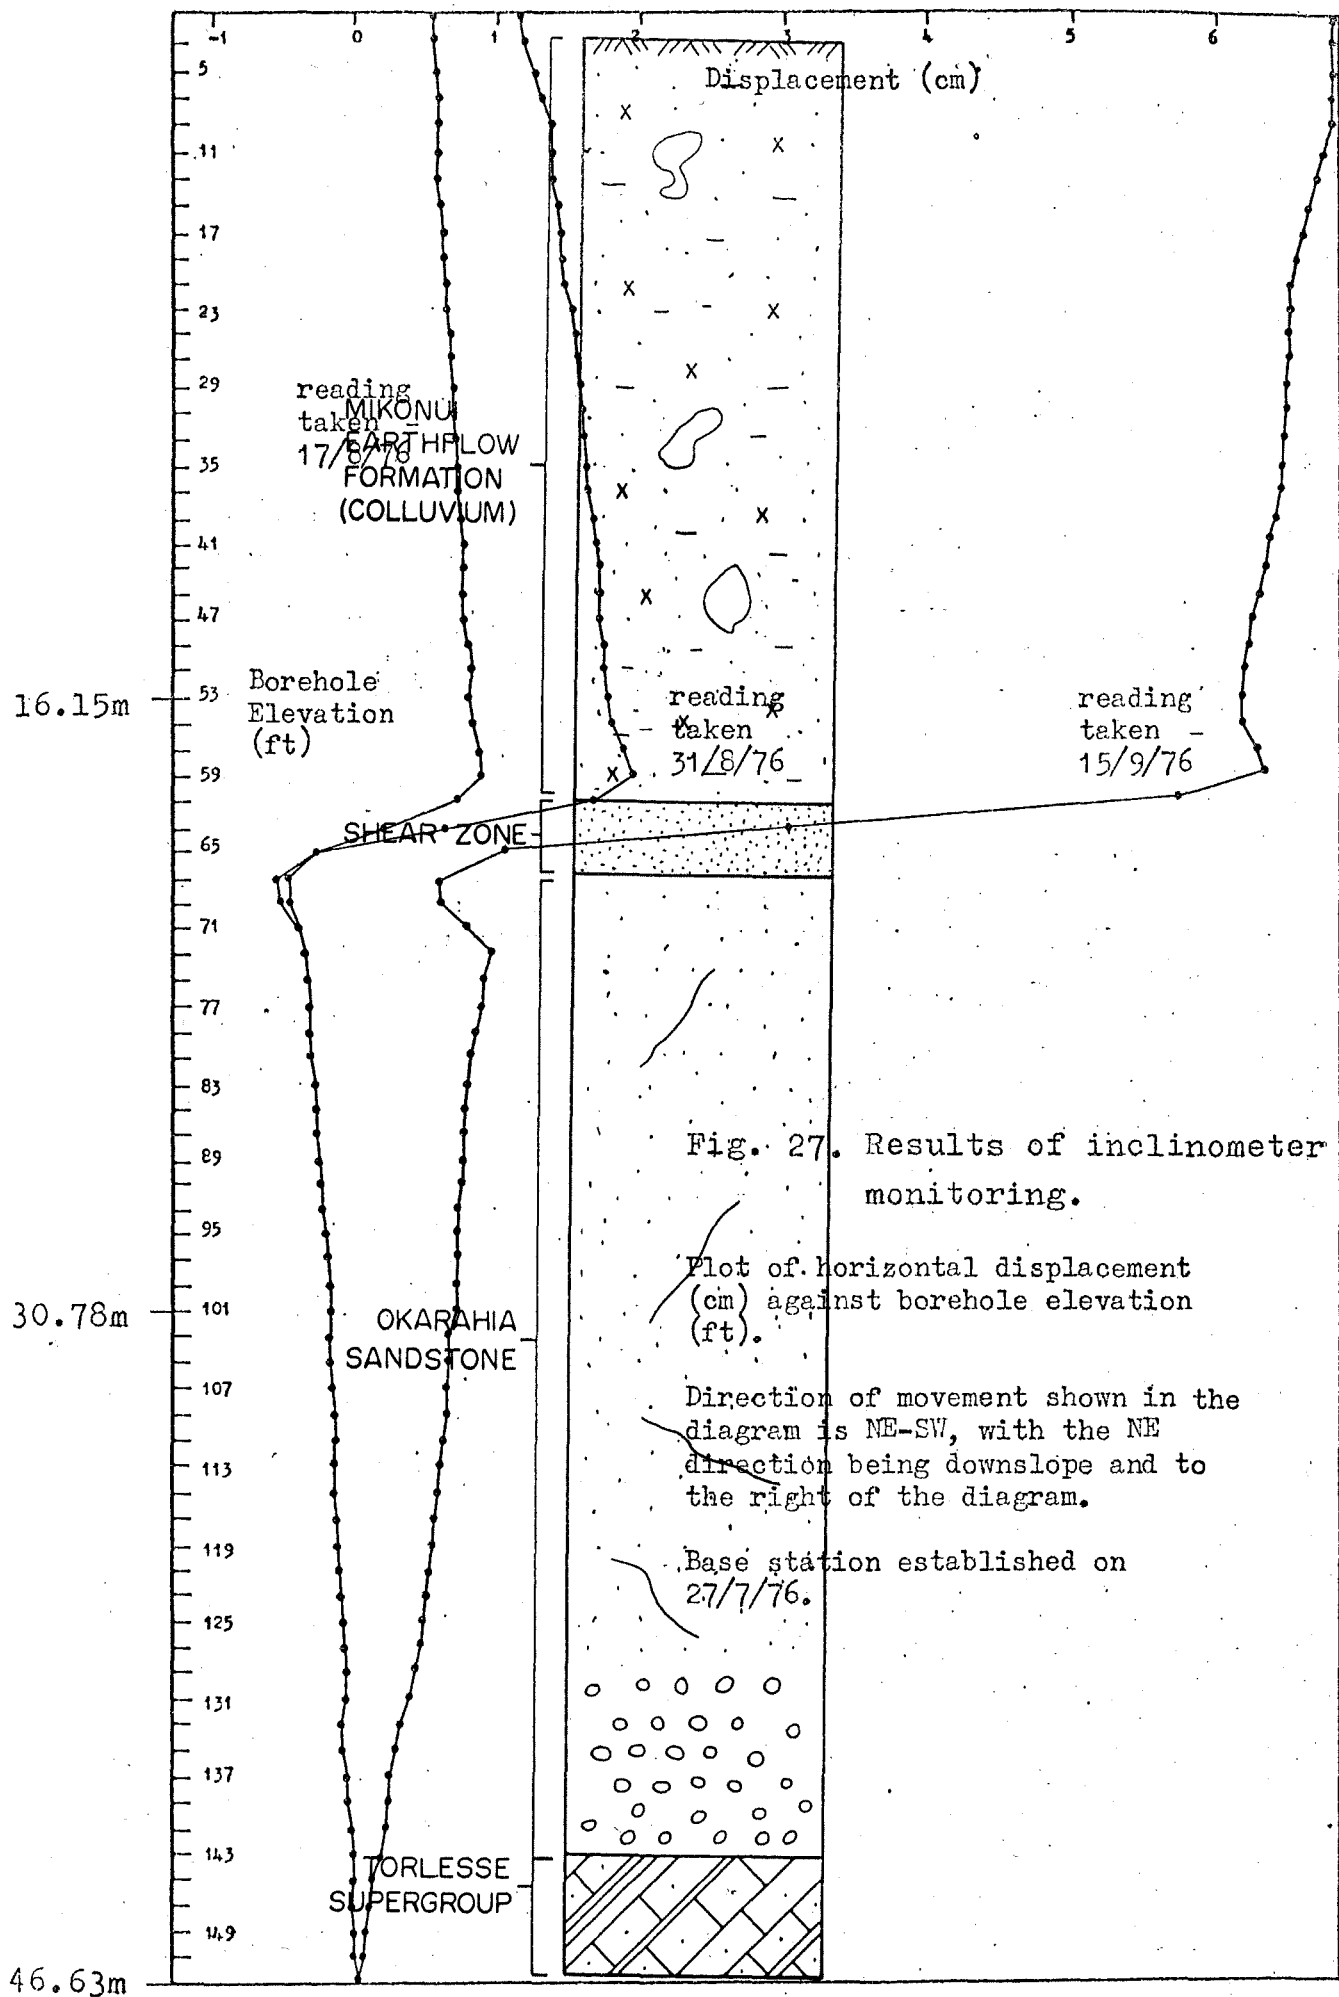
OVERLAY TO ACCOMPANY FIG. 27

Figure 27 illustrates results of inclinometer access tube monitoring in the direction of the long axis (maximum displacement) of the earthflow in borehole C. The base station was established on 27 July, 1976. Three subsequent recordings were possible; at the time of the fourth measurement (30 September), the access tube had been sheared by earth displacements.

short axis (across the earthflow) indicate a similar, albeit much smaller, horizontal displacement towards the southeast boundary of the landslide.

(d) The zone of shear extends from depths 60-66 feet (18.3-20.1m) below the ground surface.

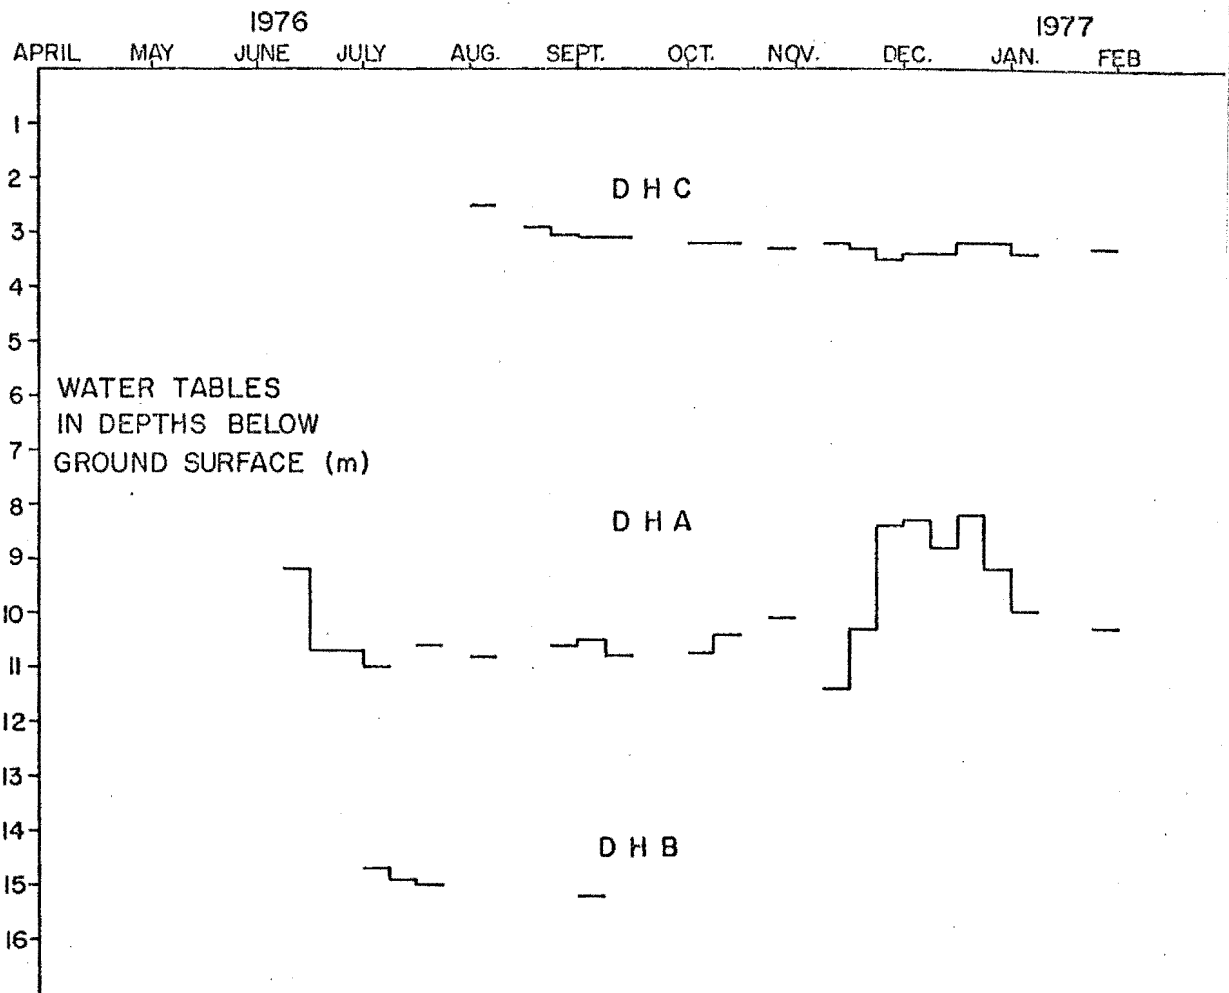
FIG. 28: ATTEMPTED CORRELATION OF WATER TABLE LEVELS WITH PRECIPITATION

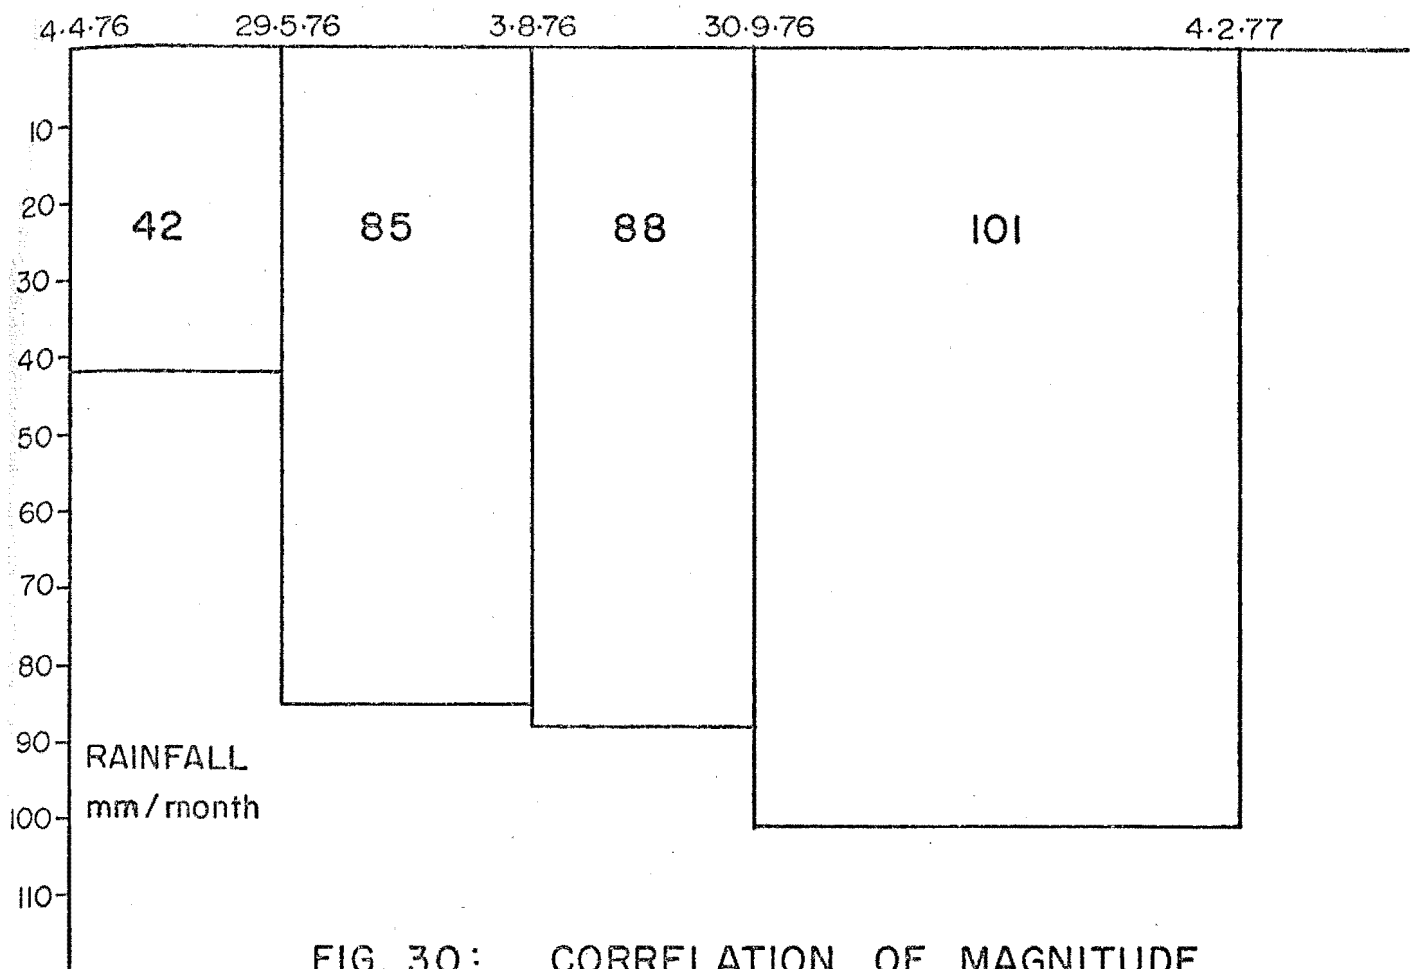
FIG. 30: CORRELATION OF MAGNITUDE
OF MOVEMENT WITH RAINFALL, STATION
NO 3, MIKONUI EARTHFLOW

(f) Rates of movement of markers per month are highly variable, ranging between 0.5-215 mm/month, and as yet appear to bear no relationship to the amount of precipitation received in the general catchment. The only exception to this, on marker No. 3, rates of movement, fortuitously or otherwise, appear to correlate with rainfall (Fig. 30). A longer survey period, however, will be needed to effect any general correlation.

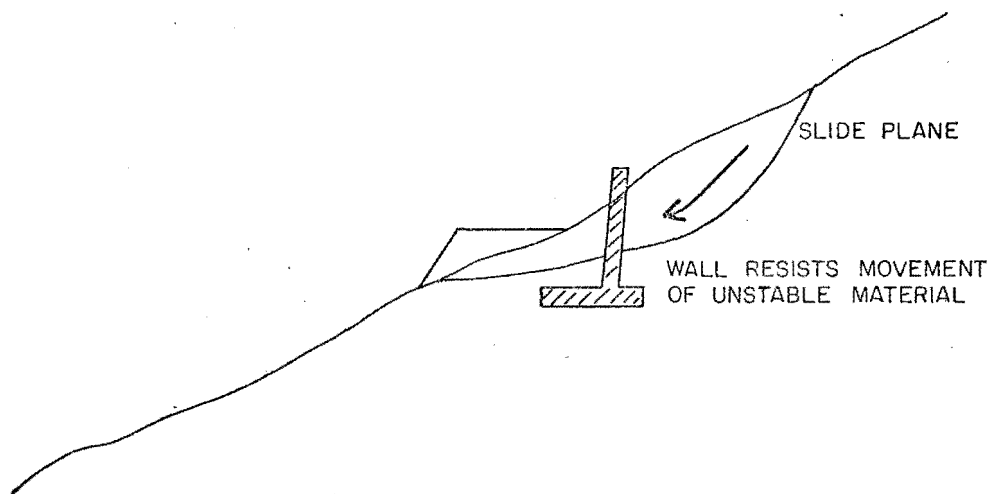
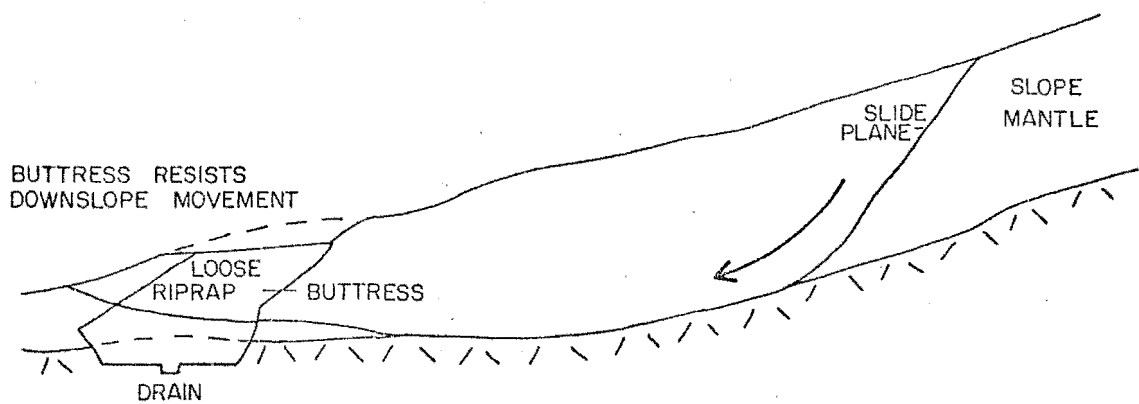
FIG. 35: RETAINING STRUCTURES

the shearing resistance of a soil mass have been perhaps the most widely mis-used landslide correction measure. Few are the cases where piling has resulted in the successful stabilization of massive earth movements. Piles are likely to be ineffective through, plastic flowage in earthflows around piles, overturning of the piles, by shear failure of piles, or by displacement of the shear surface to a depth below the pile tips.

Restraining structures would not be suitable as correction measures in the control of the Mikonui earthflow, due to the known magnitude and nature of the slope failure. Retaining walls and piling would similarly be unsuitable for use at the Ethelton Slip due to the magnitude of the landslide.

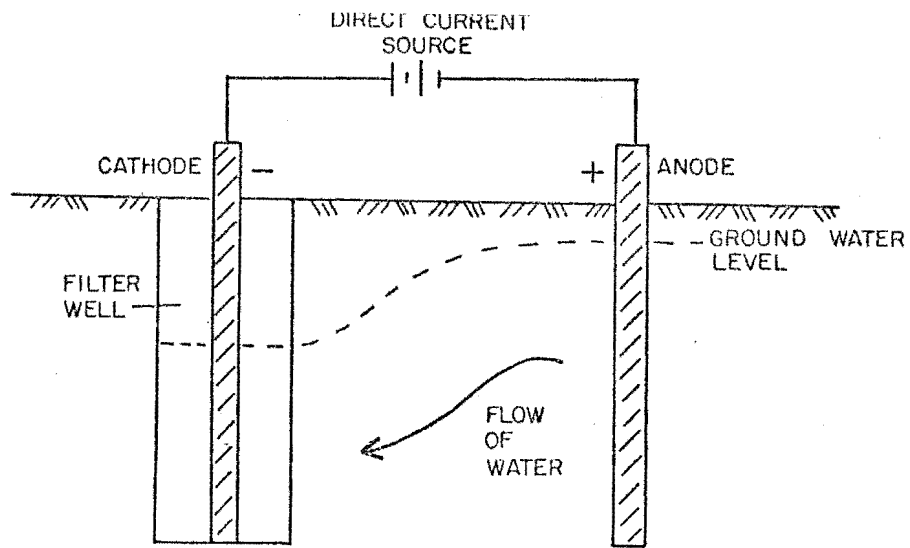
Electro-osmosis is based on the well-known phenomenon of introducing a direct electrical current between both openings of a water-filled, U-shaped flask. Water in the flask flows towards the negative electrode (cathode). This is the basis for electro-osmotic dewatering plants (Fig. 36a).

FIG. 36 a. FILTER WELL RUN ELECTRO-OSMOTICALLY BY EXTERNAL CURRENT (AFTER VEDER, 1973)

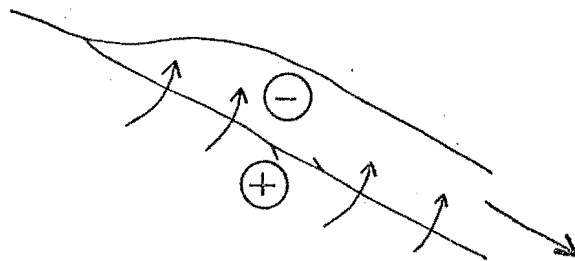
Myslivec (1969) and Veder (1973) report a naturally occurring electro-osmotic effect associated with earth movements. Under certain soil conditions, an electric field can arise on contact of mobile and immobile layers of soil in a landslide. The potential difference as a result of this electric field causes movement of water in an upward direction and, consequently, an increase in the pore

FIG. 36 b. BUILD UP OF POTENTIAL DIFFERENCES BETWEEN SLIP AND STABLE GROUND CAUSING UPWARD MIGRATION OF WATER (AFTER VEDER, 1973)

pressure above the slide surface (Fig. 36b).

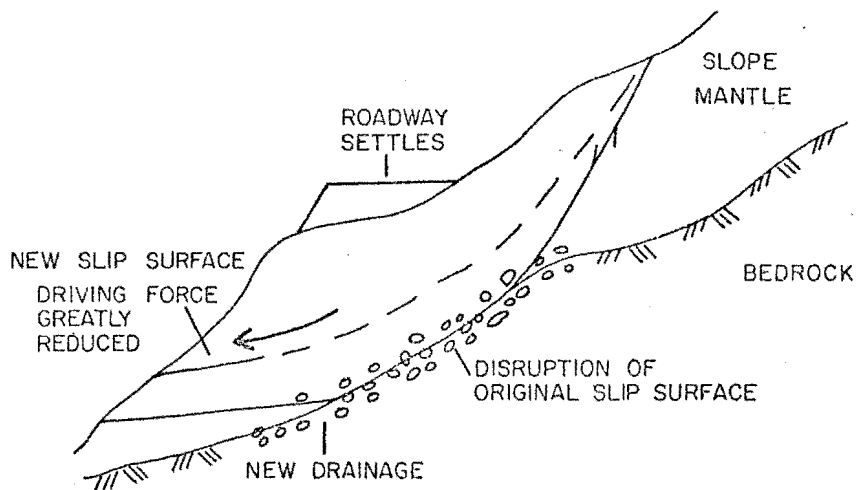
FIG. 36 : BLASTING TECHNIQUE (AFTER BAKER 1960)

5.26.2 Blasting. Partial or complete disruption of a failure surface by blasting remains the most contentious landslide correction measure. The technique has had results ranging from spectacular success to dismal failure.
